## **TESTS AND RESEARCH**

### **Airframe**

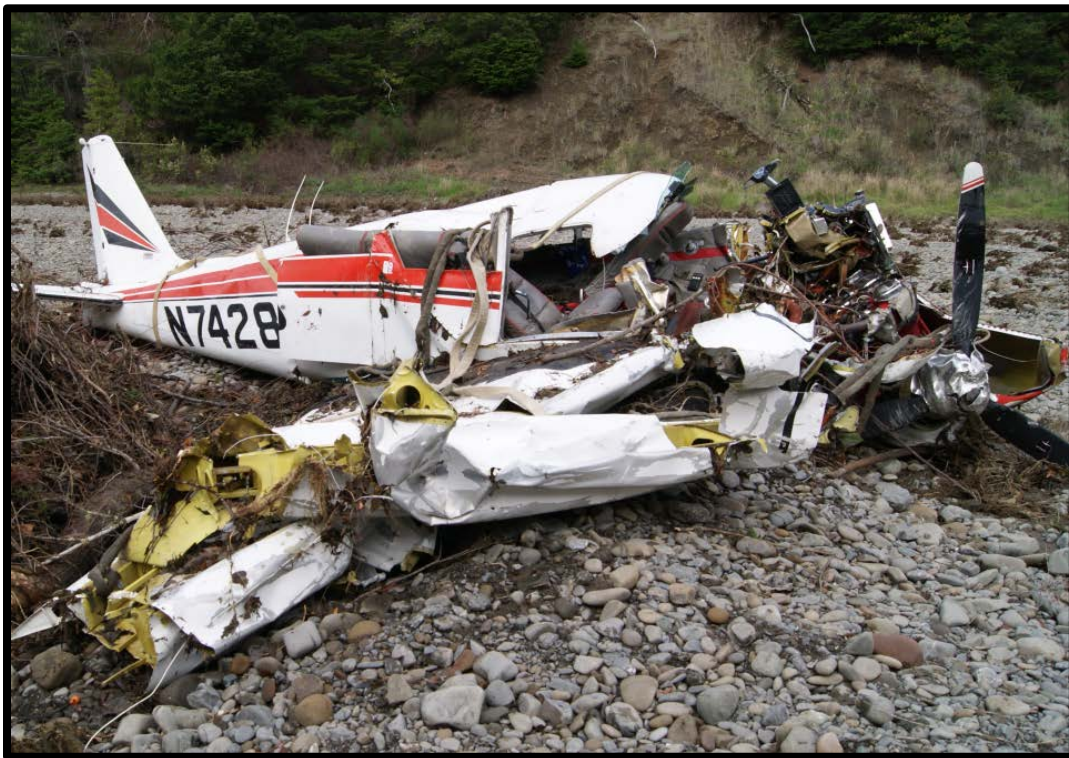
The right wing was separated for recovery purposes and contained crush damage to the leading edge about three feet outboard. The fuel tank on the outboard right wing was found full of fluid consistent an odor and appearance of avgas. The right flap remained attached and was physically in the retracted position. About six feet outboard from the wing root, the right wing exhibited crush damage debris was embedded in the wrinkled skin. The wing tip was absent.

The rudder and vertical stabilizer remained intact. The right horizontal stabilizer sustained crush damage to the tip. The left horizontal stabilizer and attached elevator were creased. The left horizontal stabilizer tip was absent.

The nose gear appeared retracted and twisted aft and under the engine. The right main remained in the wheel well.

*Picture 1: Accident Site*

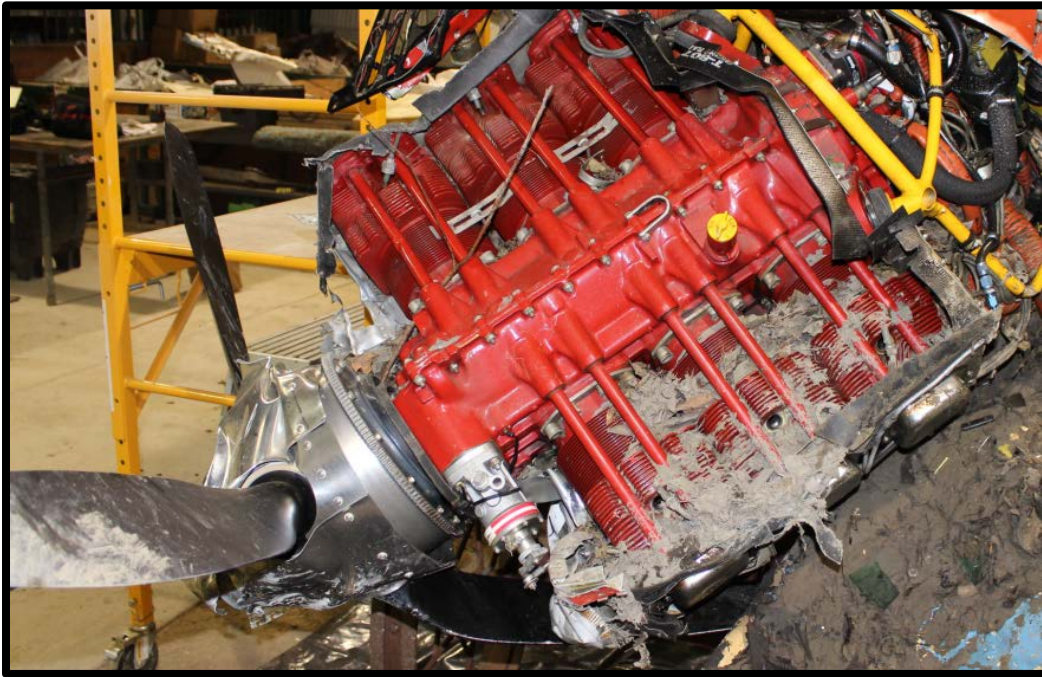
The engine remained attached to the airframe and mounts with crush damage observed on the firewall. An external visual examination of the engine revealed no evidence of pre mishap catastrophic mechanical malfunction or fire. Damage was noted on the nos. 1 rockerbox cover, where crush deformation was observed. The airbox was disconnected

from the carburetor and scat tubing was disconnecting. The propeller spinner was crushed aft.

*Picture 2: Engine (view from top)*
